Public Buildings Enhanced Energy Efficiency Program

Investigation Report for BCA Bemidji

7/25/2012

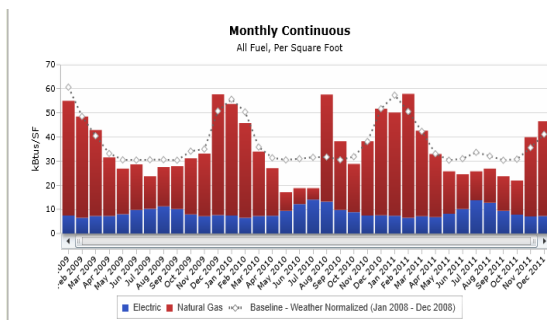
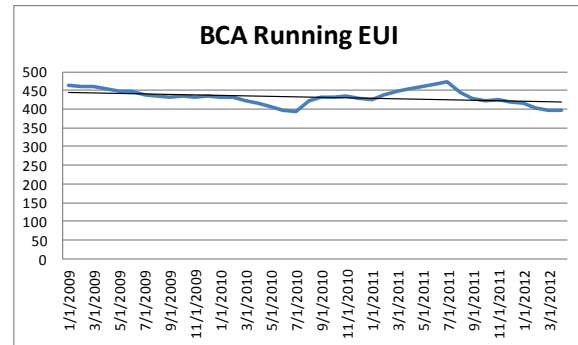
Year	Days	SF	Total kBtu	Normalized Baseline kBtu	Change from Baseline kBtu	% Change	Total Energy Cost \$	Average Cost Rate \$ /kBtu
2009	365	26,854	11,671,076	12,229,293	-558,217	-5%	\$114,993.23	\$0.01
2010	365	26,854	11,542,499	12,096,624	-554,125	-5%	\$119,978.91	\$0.01
2011	365	26,854	11,247,809	12,045,697	-797,888	-7%	\$133,110.10	\$0.01

The energy use at BCA Bemidji decreased approximately 6% over the period of the investigation.
